## Replacement of the 3rd brake light

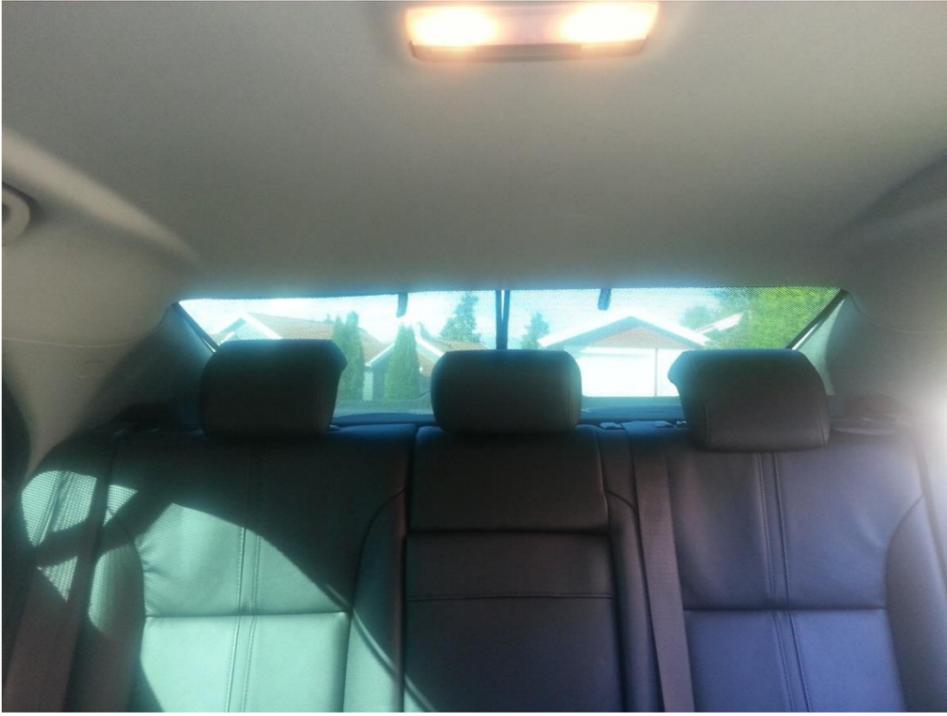
The area to dismantle (fold down the rear seats).

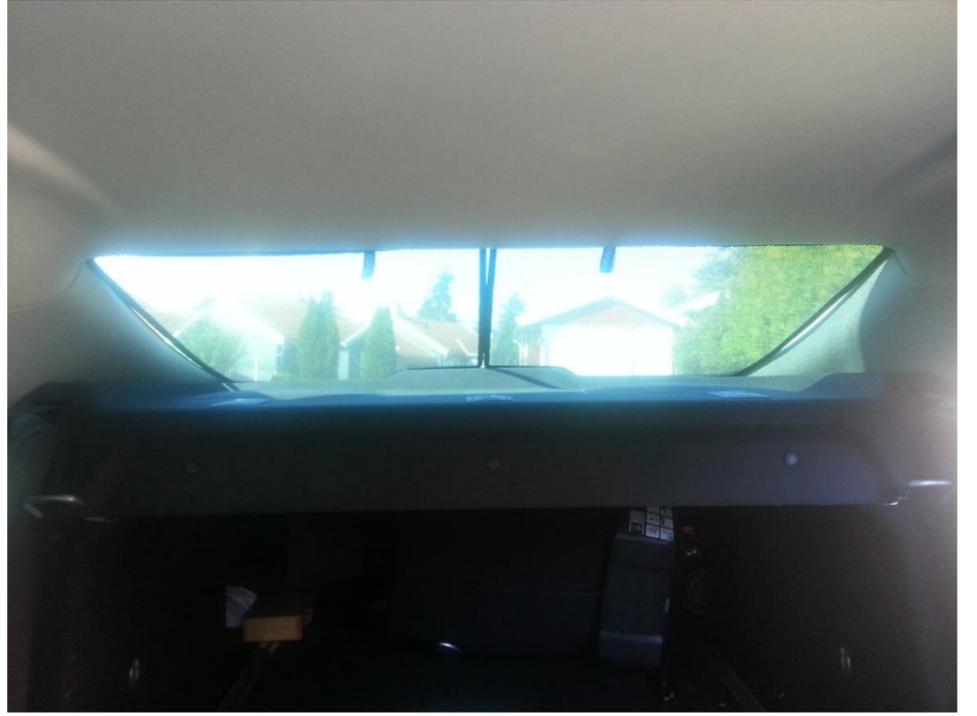
There are 3 panel trim retainers and those are easy (use a flat bladed tool).

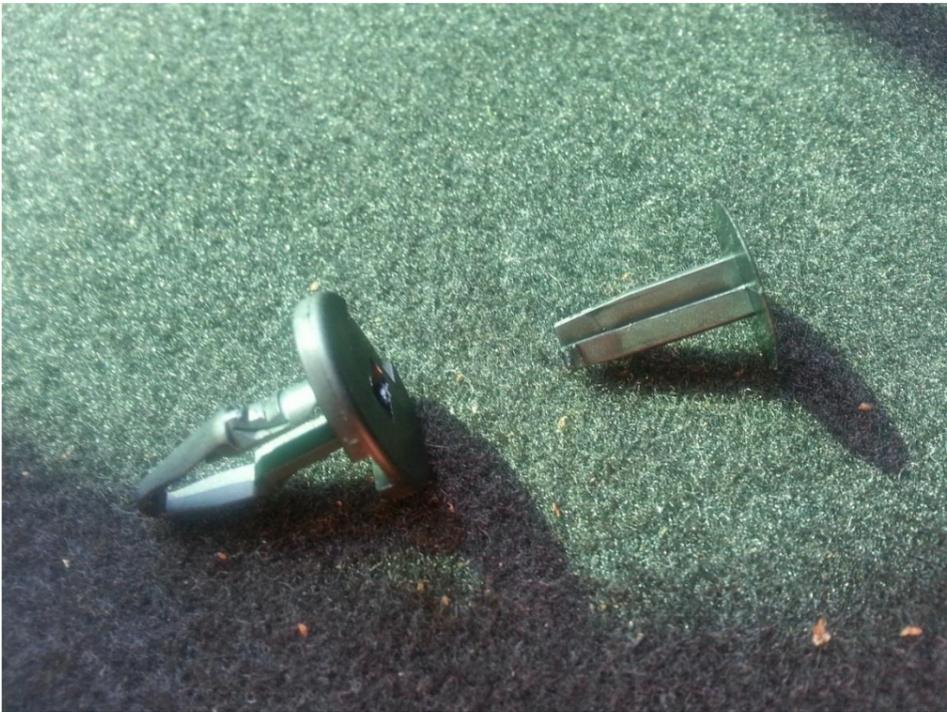
Panel trim retainer (Qty 3).

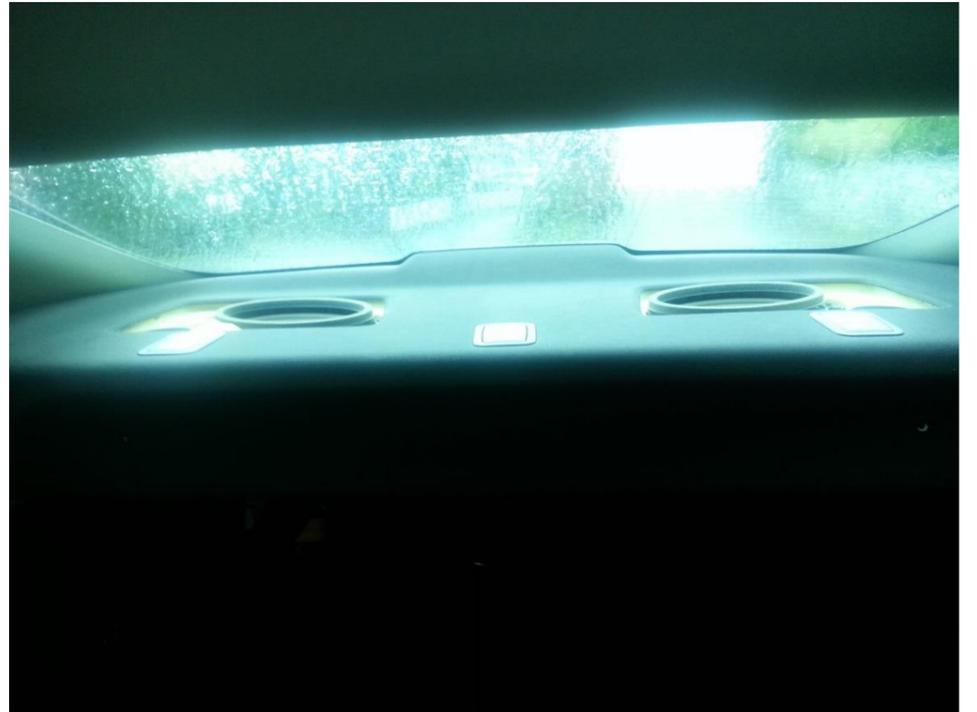
Don't think it's needed, but I took off the top of the soundsystem.

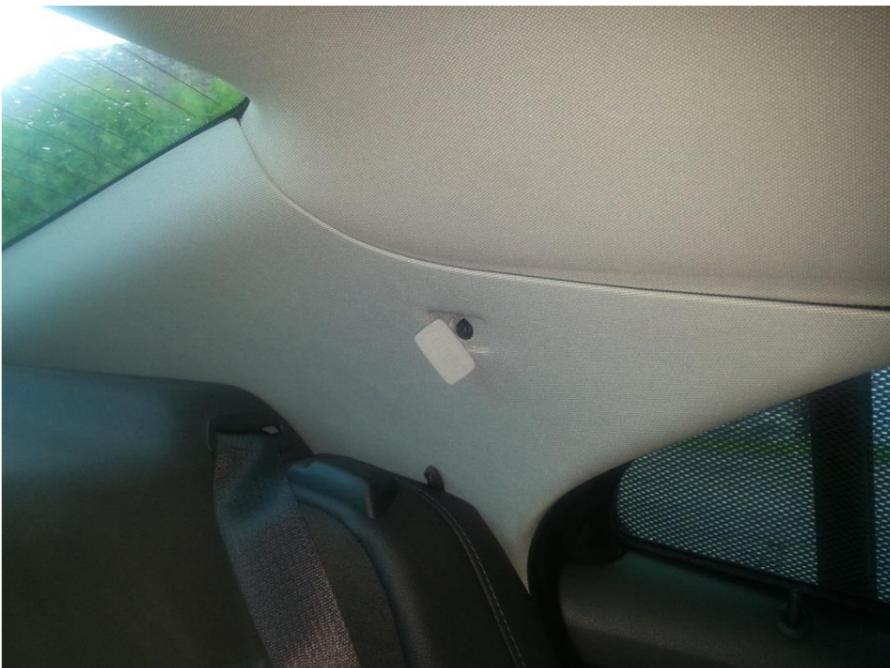
C-Pillar's upper trim panel.

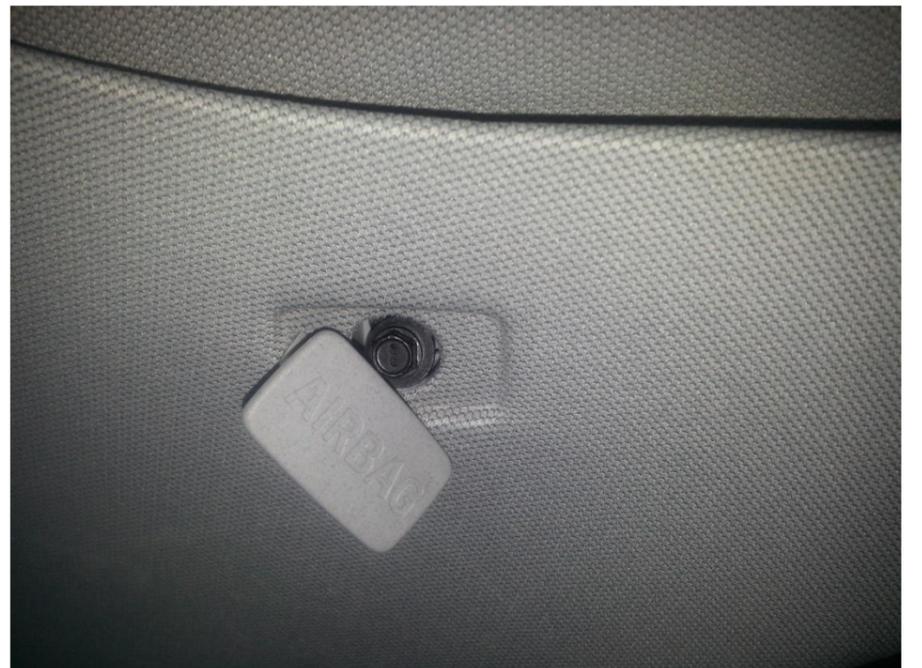
Use a flat bladed tool to release the retainer from the C-pillar panel.

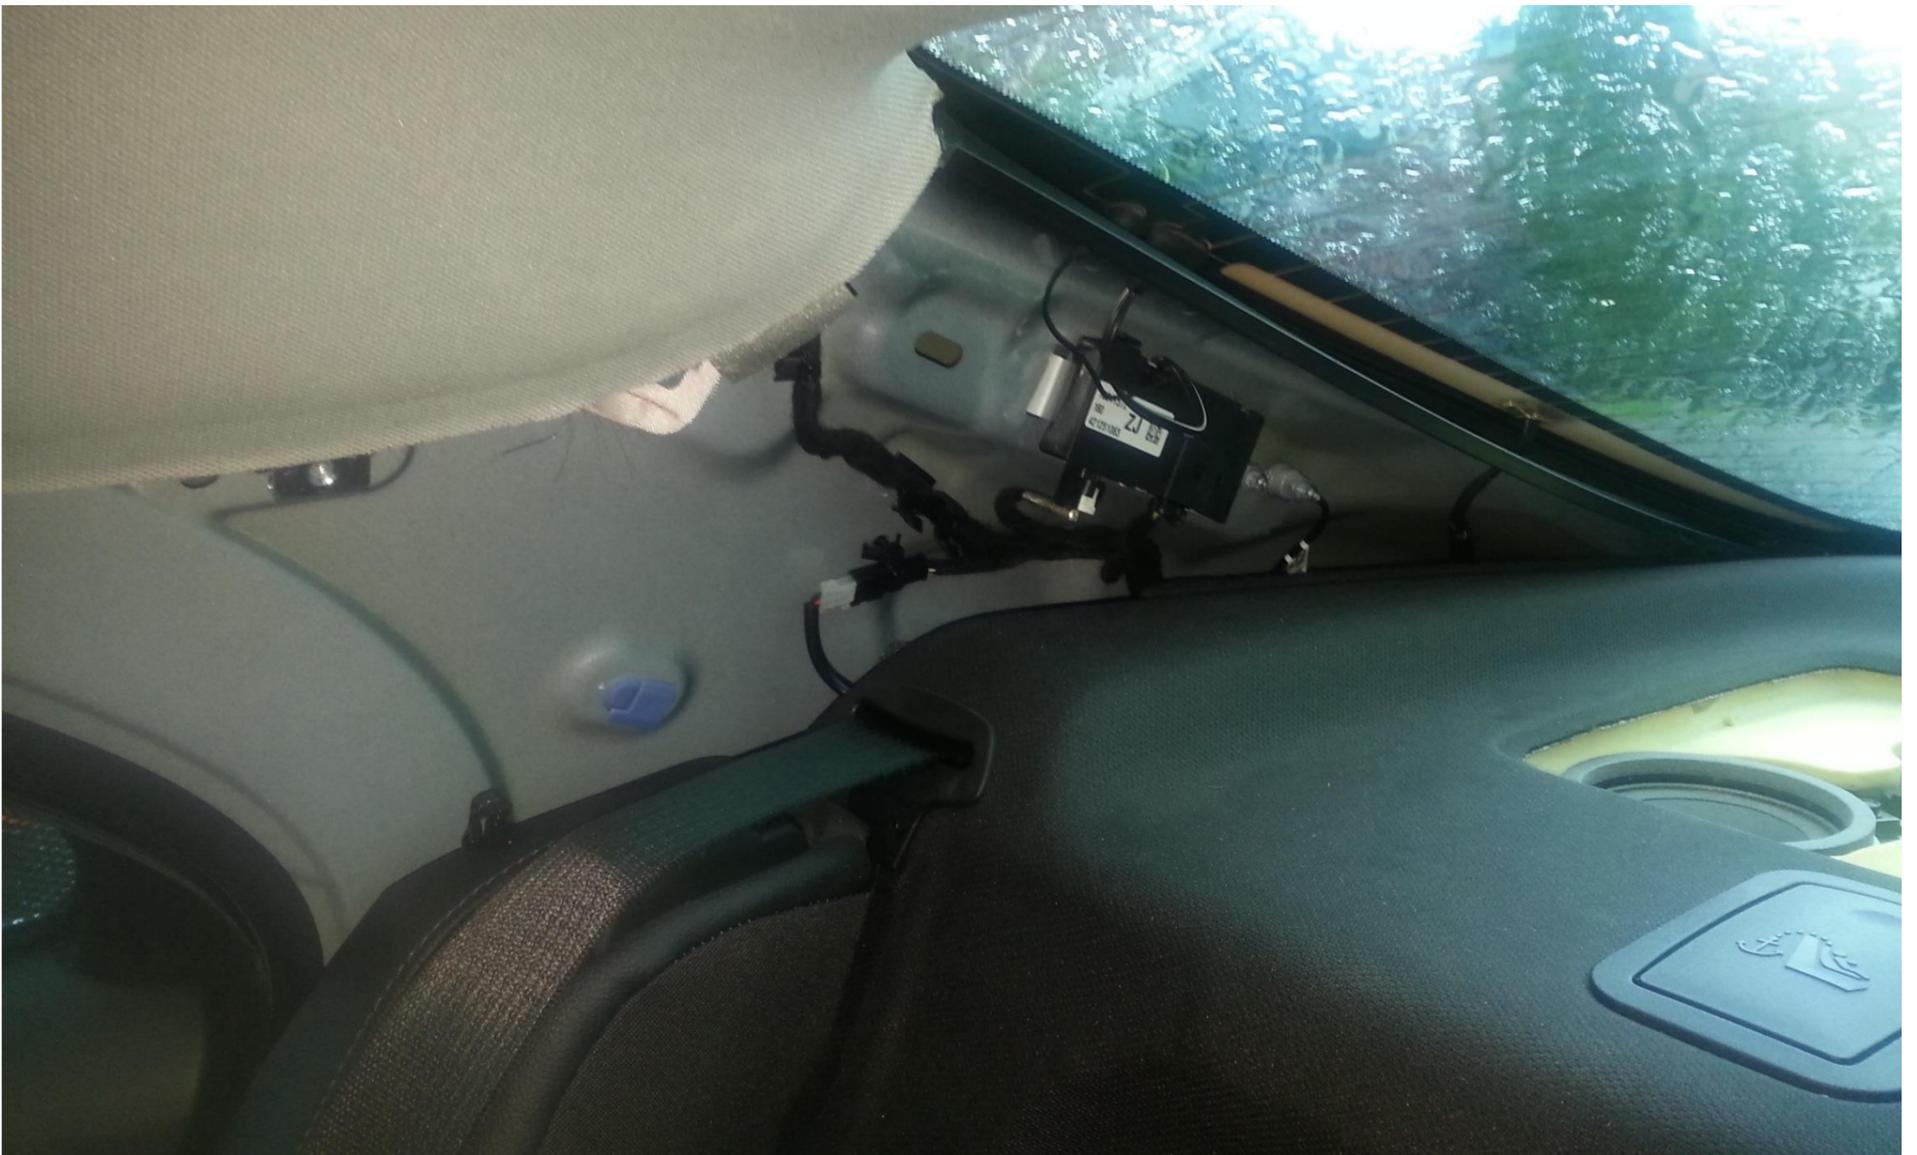
When the screw is off pull the C-pillar panel towards you carefully until the 3 brackets are off, and then pull it in the direction of the front of the car.

Disconnect the white electrical connector in the middle of the picture above (use a small flat bladed tool to unlock the connector).

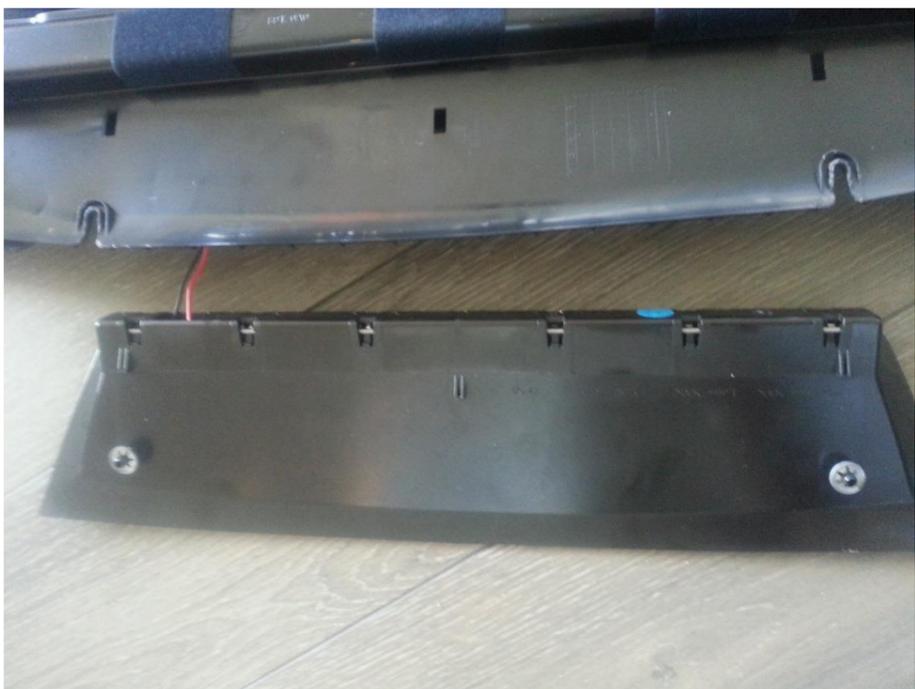
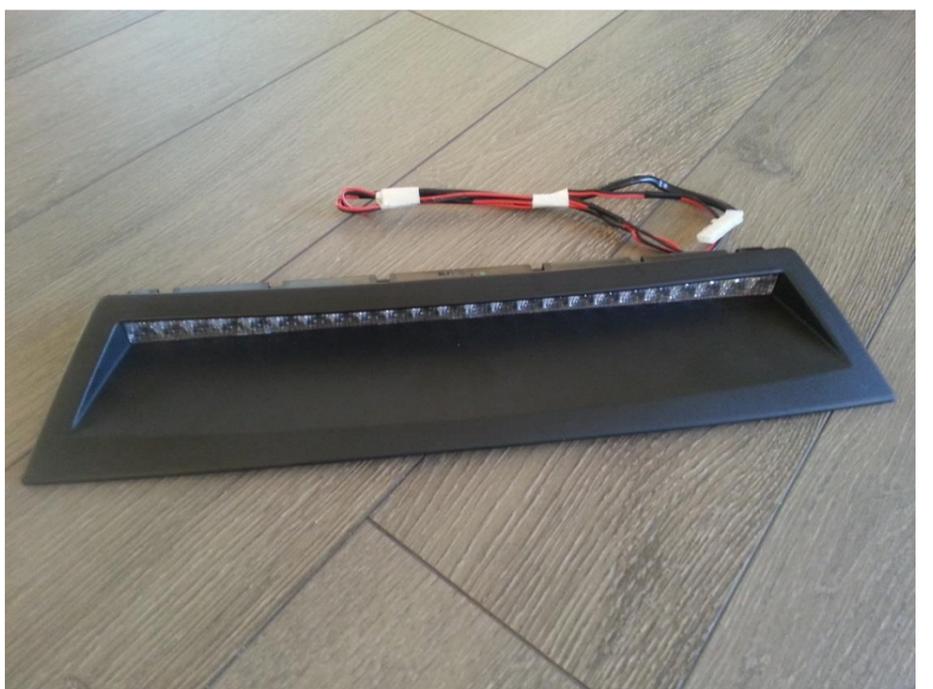
The old one is off and...

The new one is ready to go on shining ☺

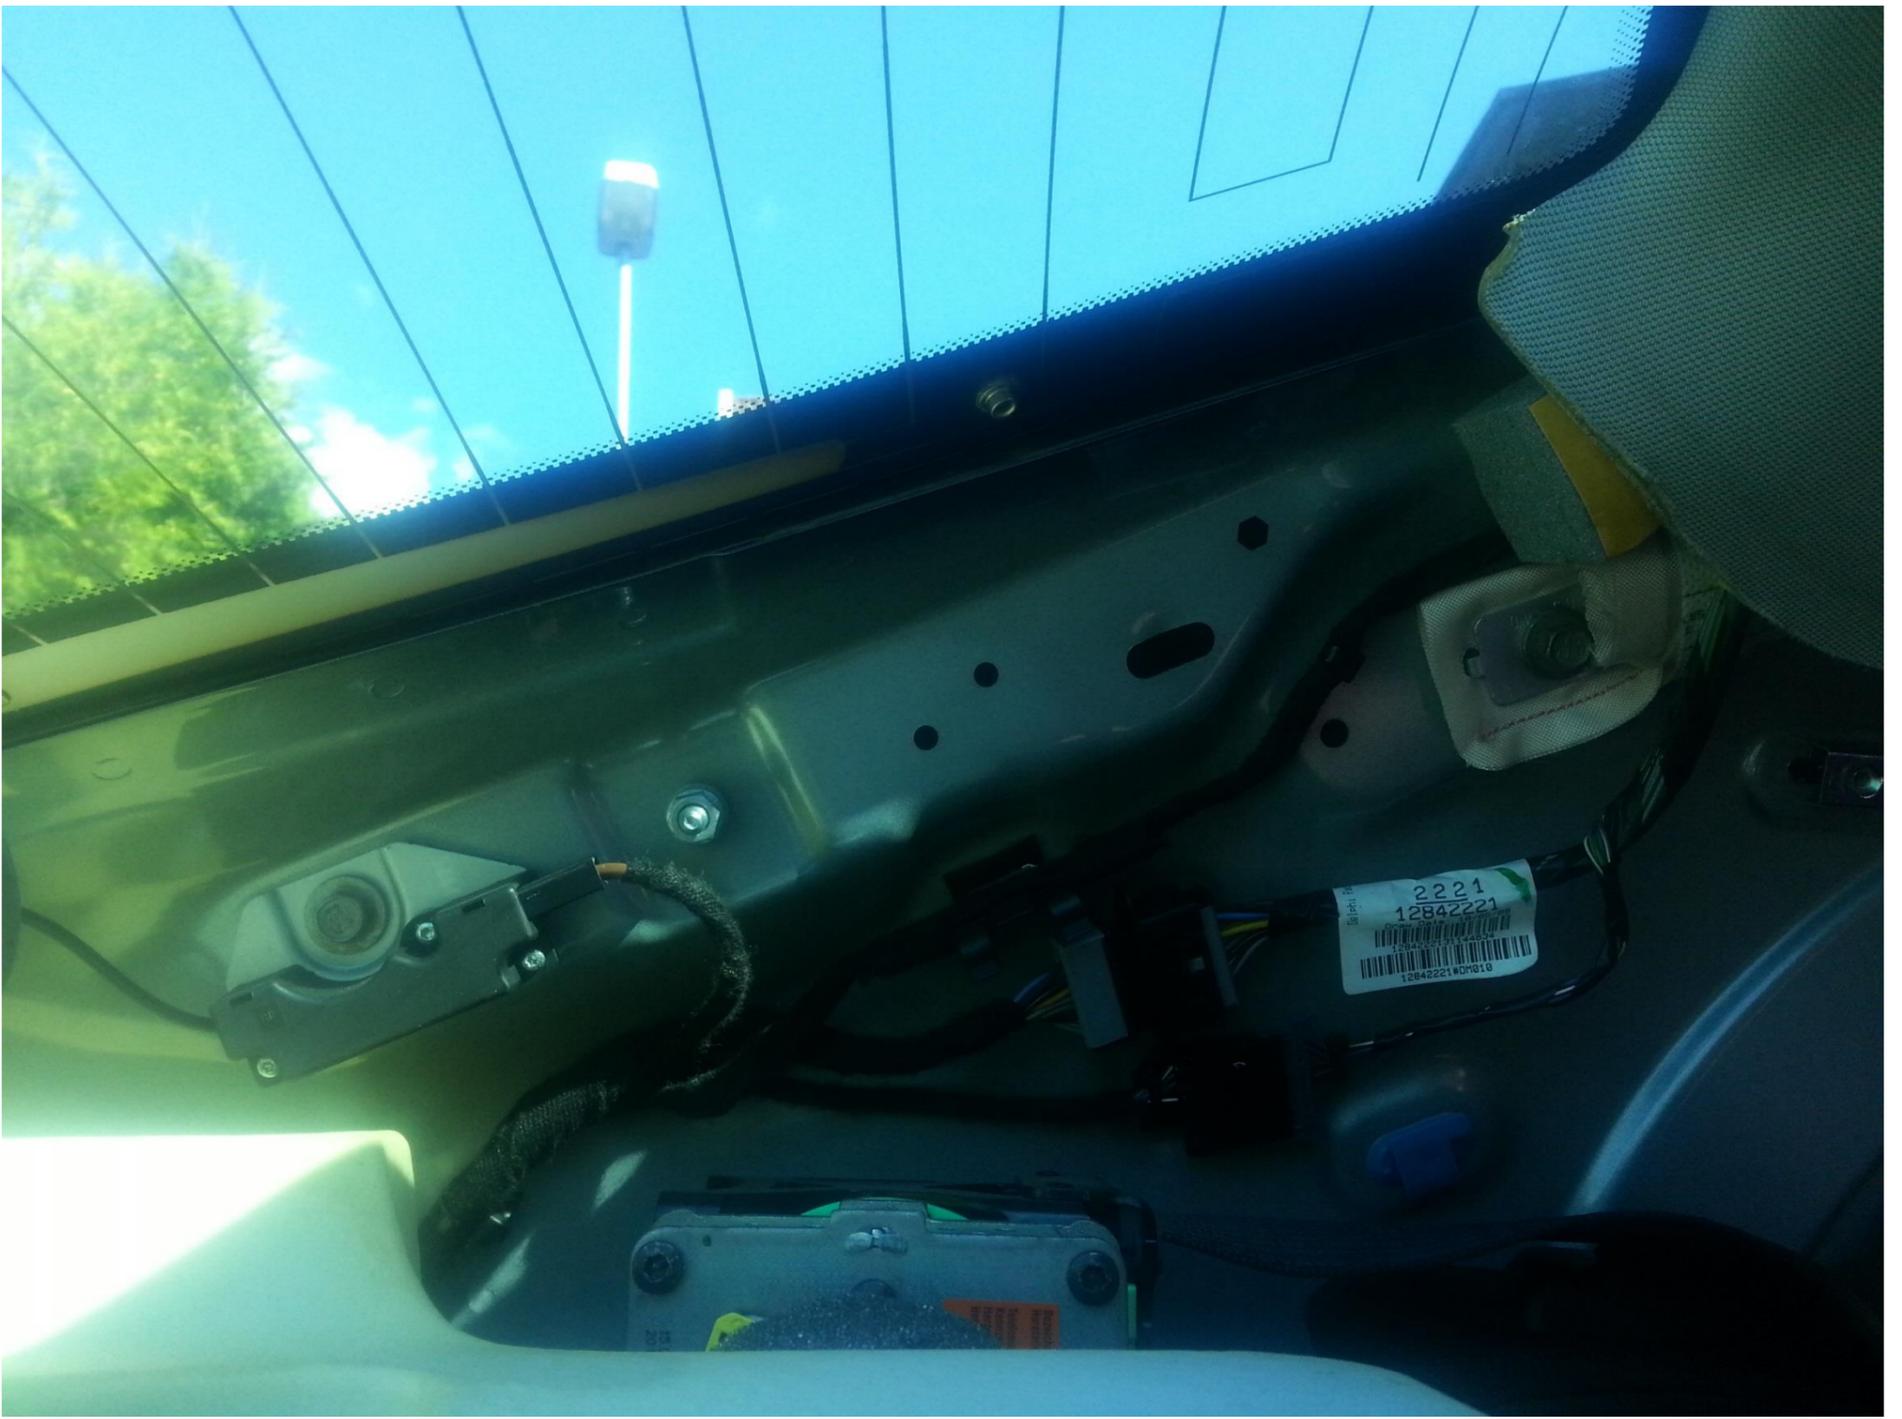
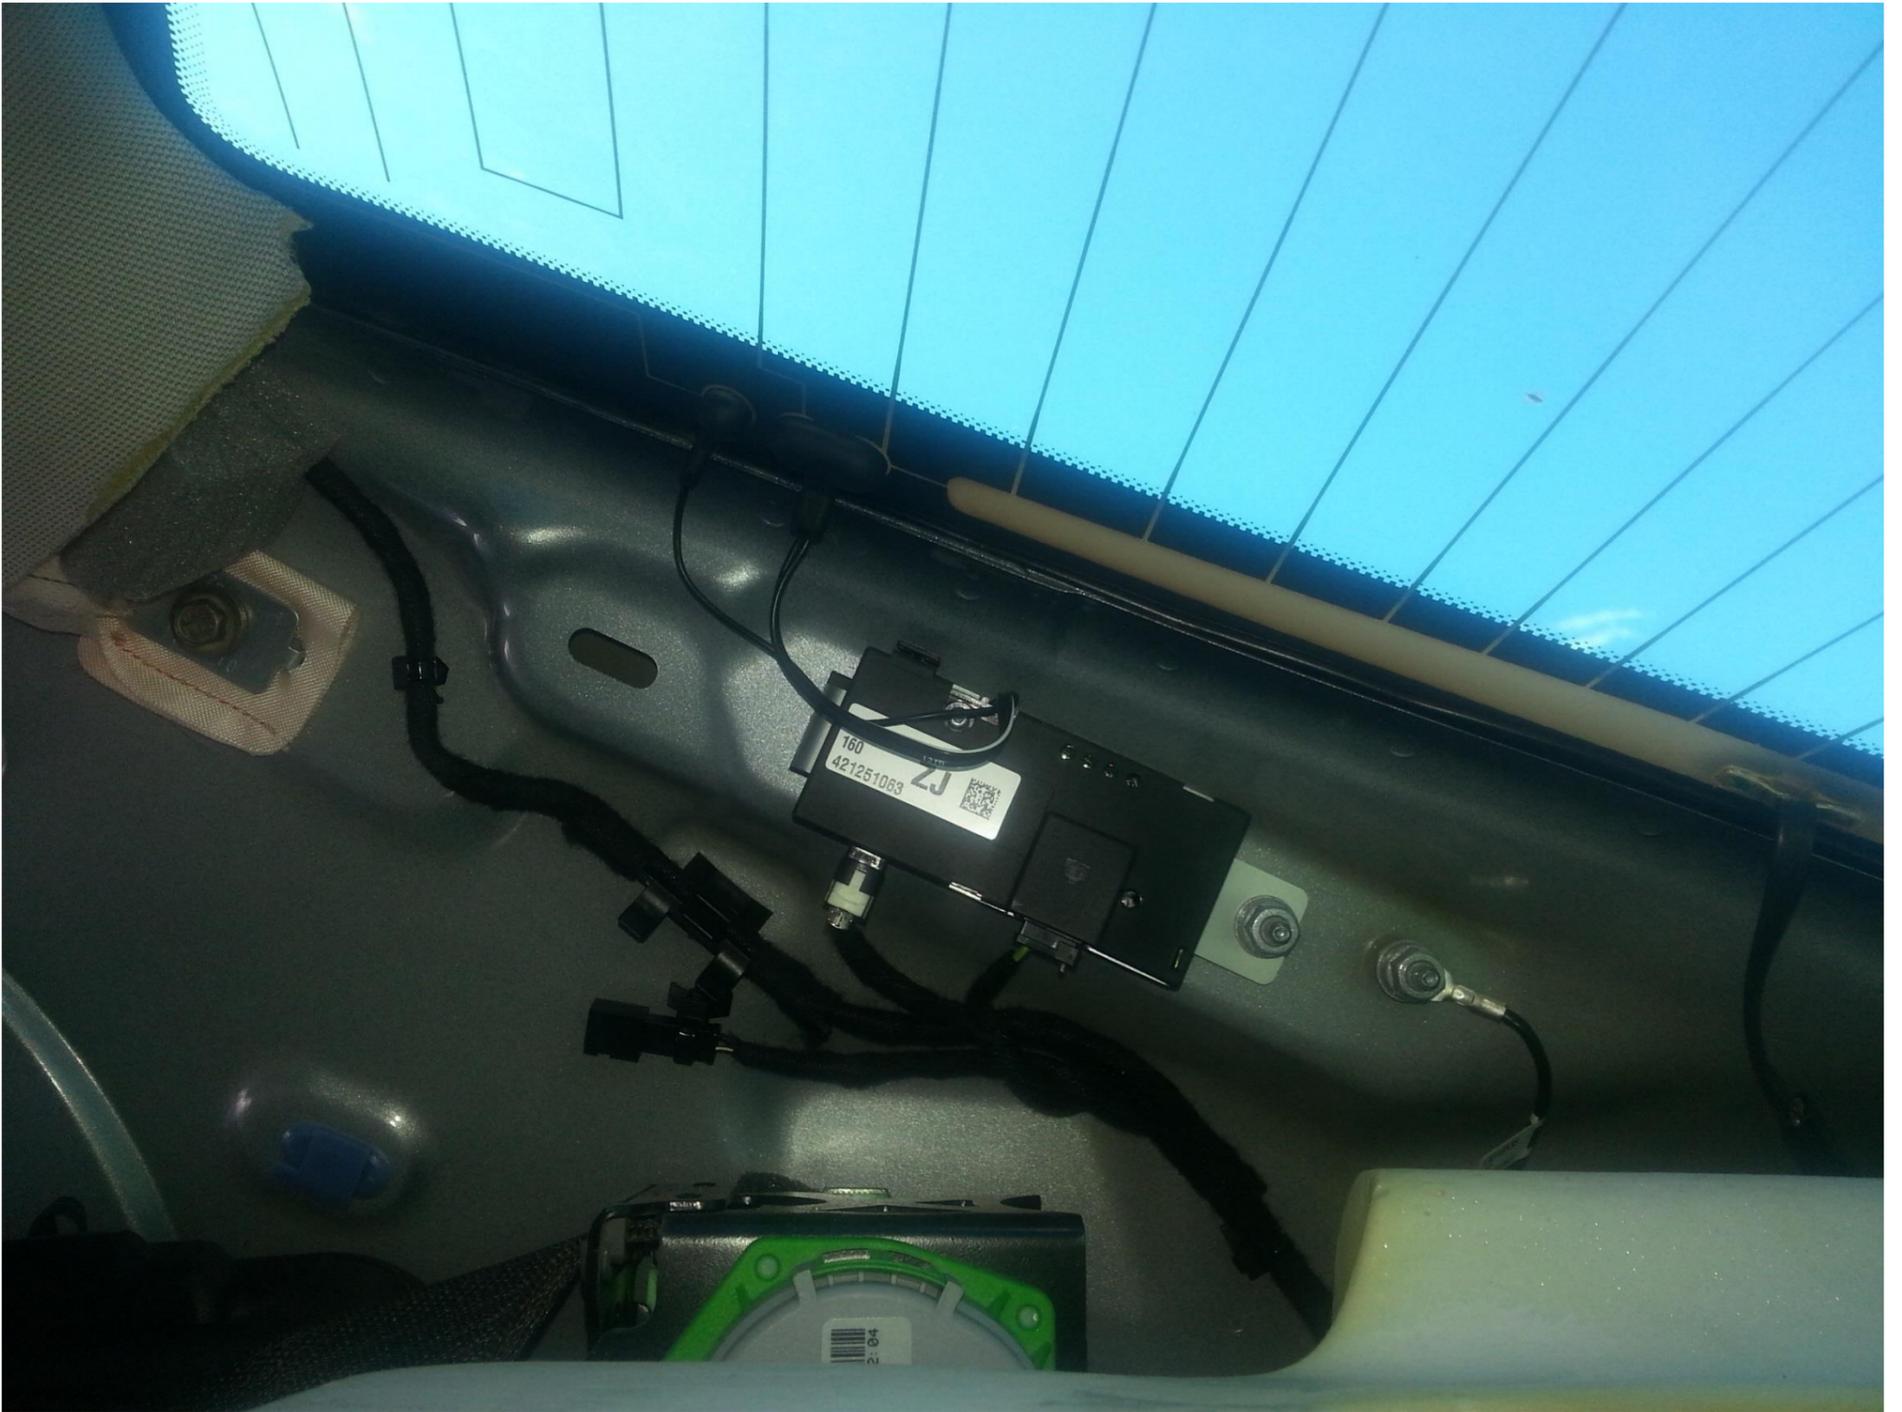
If someone is apprehensive about pulling out the c-pillar covers because of the airbags. Here are some pictures where you can see that they are placed from the C-pillar and up over the doors.
